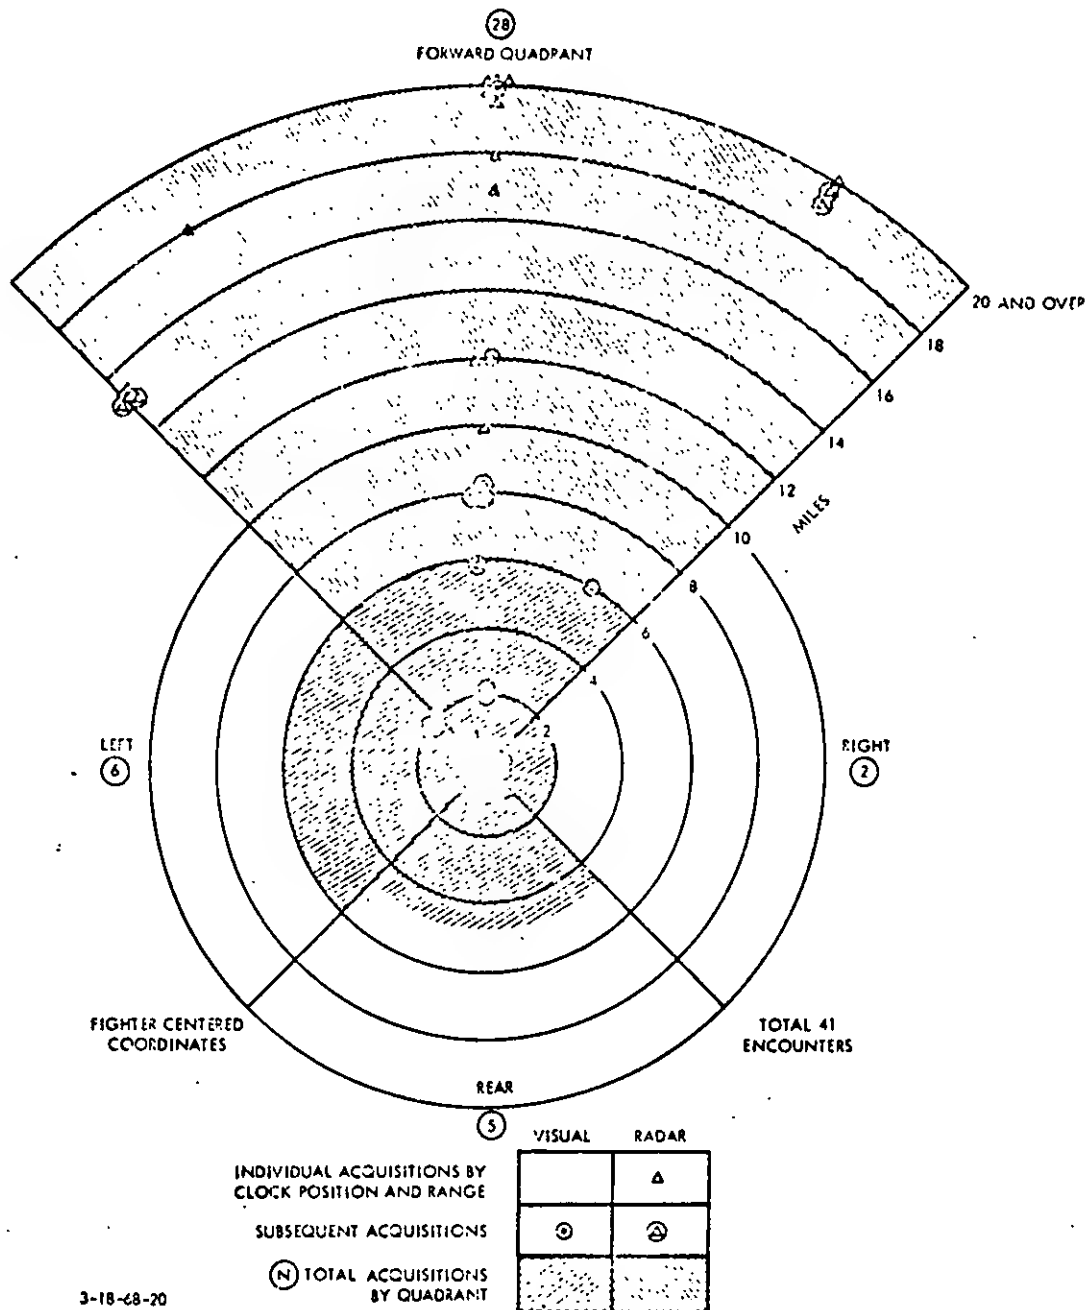
FIGURE III-A6 (S). F-4, F-8 Acquisitions Versus Range Commencing with Initial Radar Acquisition, 1 April 1965 Through 1 August 1967 (U)

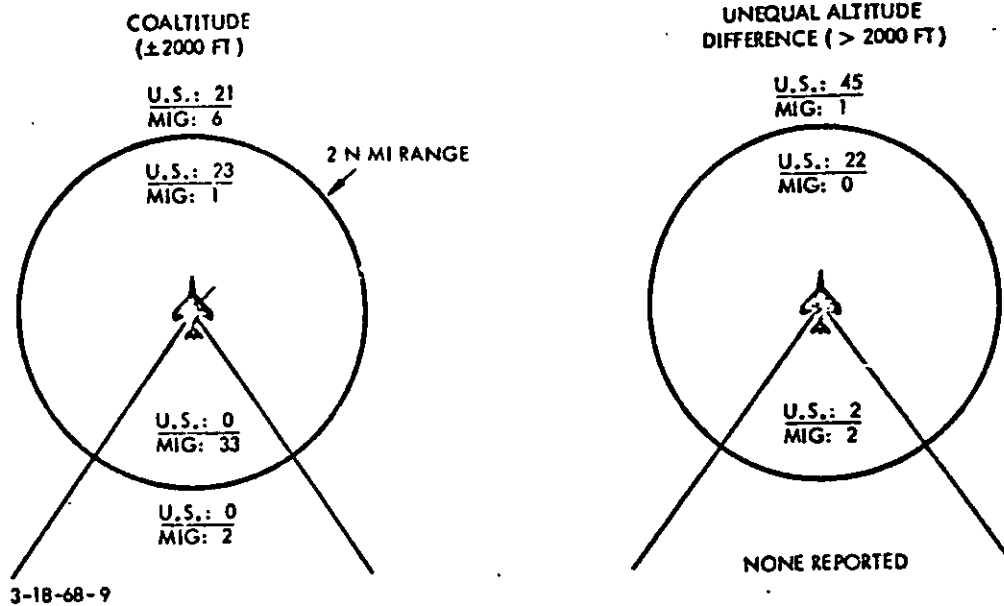
FIGURE III-B2 (S). Ratio of U.S. to MIG-17 First Firings for Different Acquisition Conditions (U)

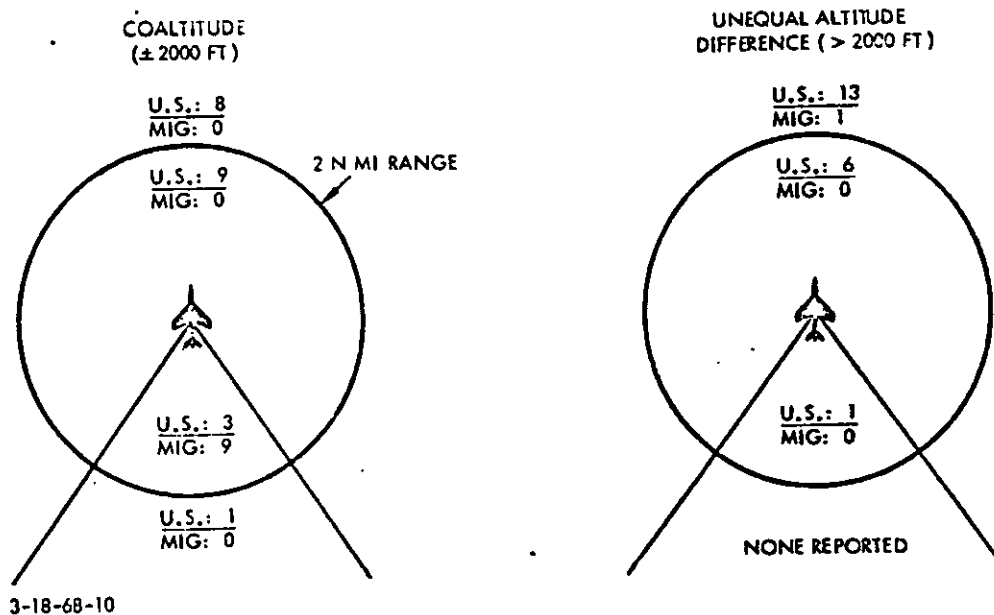
FIGURE III-B3 (S). Ratio of U.S. to MIG-21 First Firings for Different Acquisition Conditions (U)

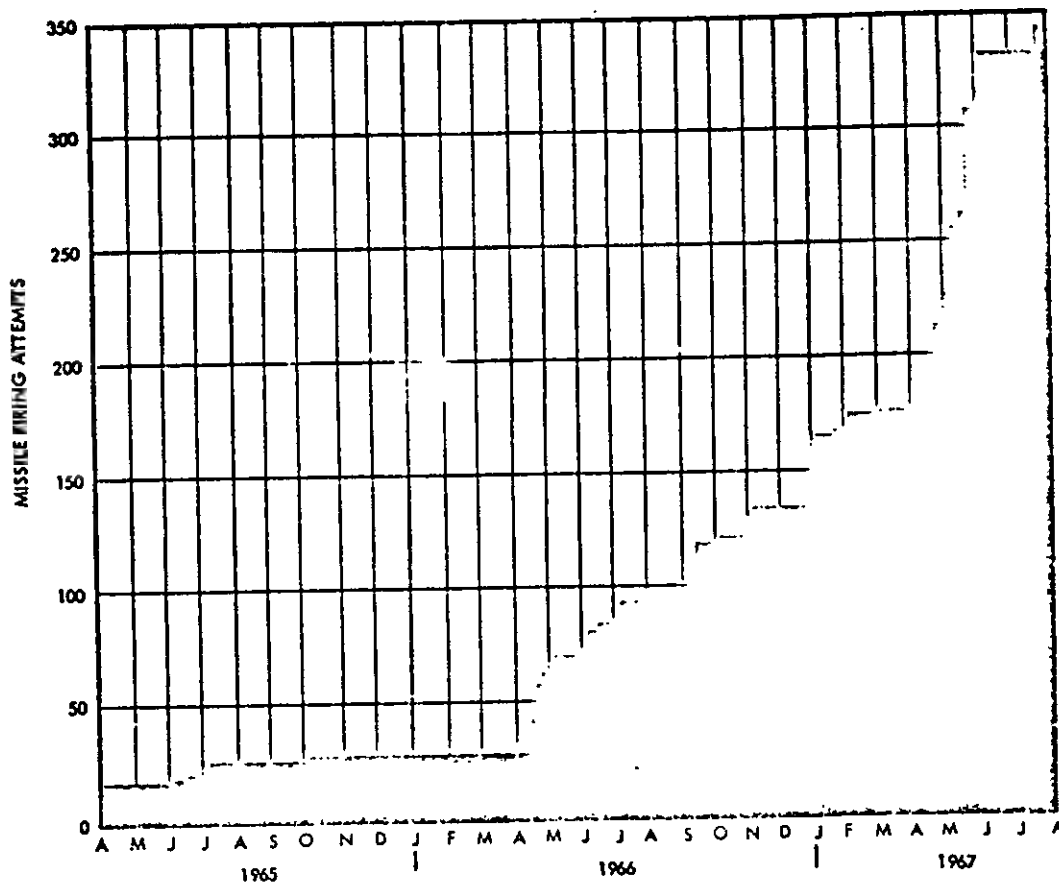
FIGURE III-C4 (S). Cumulative Total of Missile Firing Attempts
April 1965 to August 1967 (U)

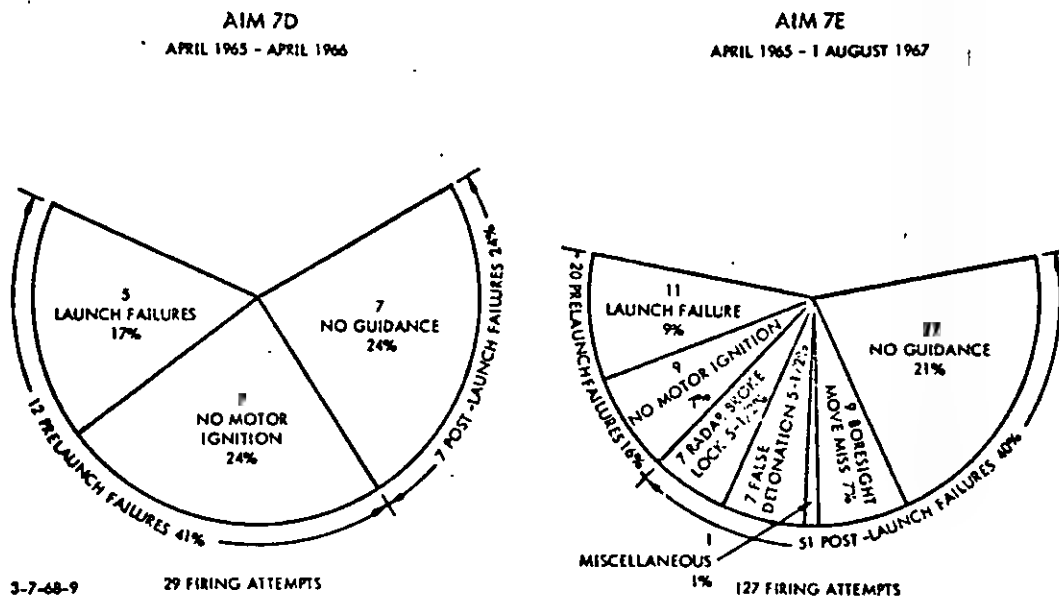
FIGURE III-C6 (S). AIM-7 Missile System Failures (U)

(S) The AIM-7D was employed in SEA from April 1965 through April 1966. The AIM-7E replaced the AIM-7D in April 1966 and has been used since that time. The summary of AIM-7 results is shown in Figure III-C5, while Figure III-C6 further subdivides the missile system failures. Note that the fraction of attempts fired out-of-envelope is small and that the fraction of prelaunch failures of the AIM-7D has been reduced. When considering the postlaunch results of the AIM-7E, the environment should be examined. Figure III-C7 combines a time-based histogram of AIM-7D and AIM-7E firing attempts (subdivided into Hits, Missile System Failures, and other results) with a target maneuvering, non-maneuvering dichotomy

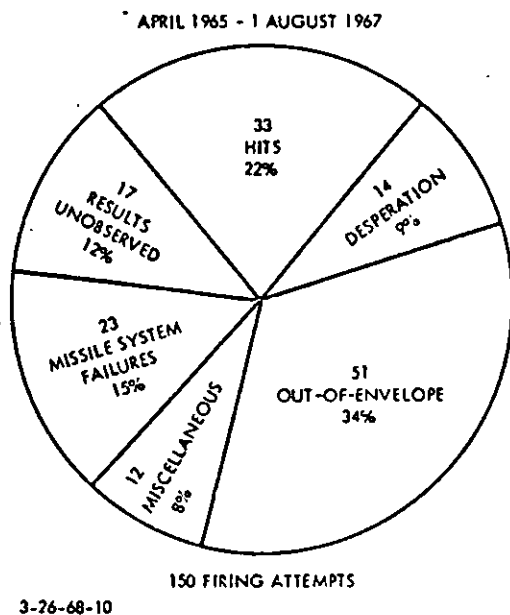
FIGURE III-C9 (S). AIM-9B Summary (U)

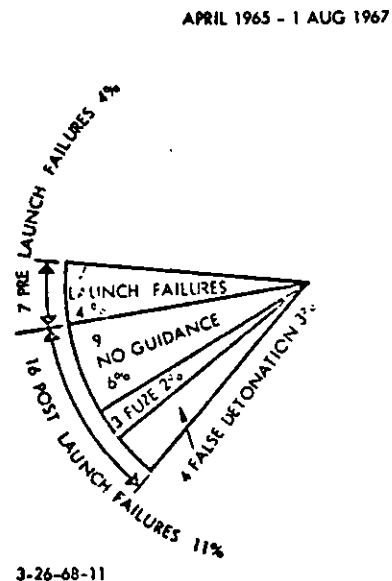
FIGURE III-C10 (S). AIM-9B Missile System Failures (U)

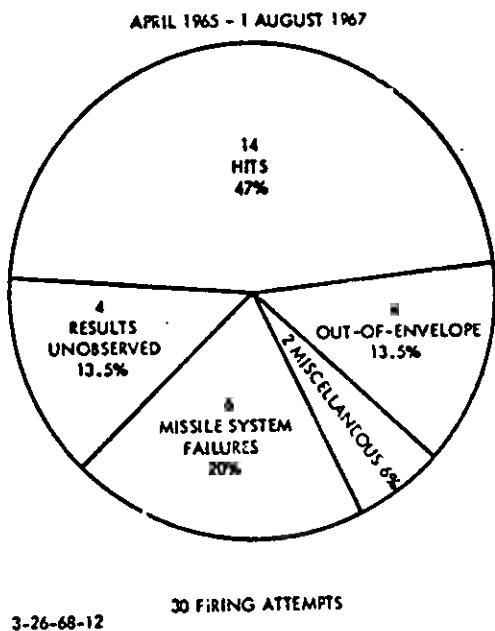
FIGURE III-C12 (S). AIM-9D Missile System Failure (U)

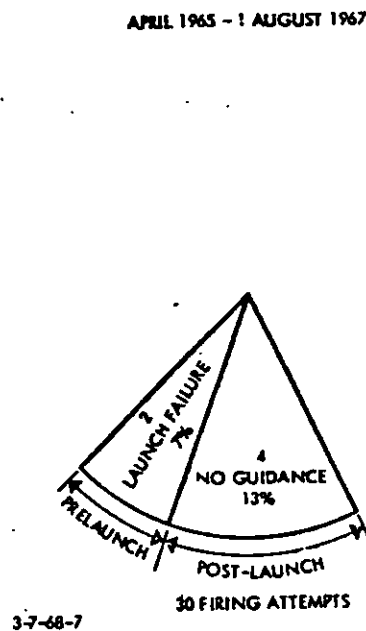
FIGURE III-C11 (S). AIM-9D Summary (U)

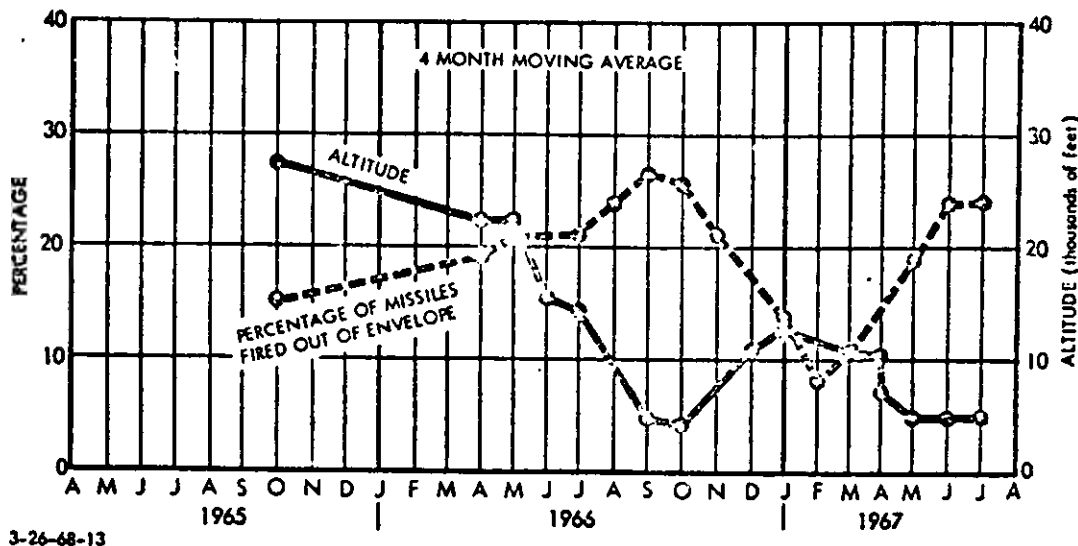
(S) There are a variety of contributing causes to the out-of-envelope phenomenon; among these are missile type, aircraft g's, target g's, and altitude at time of firing. Although less obvious, the effect of altitude on out-of-envelope firings becomes apparent by a comparison of envelopes at

FIGURE III-C14 (S). Comparison of Altitude and Out-of-Envelope Ratio (U)

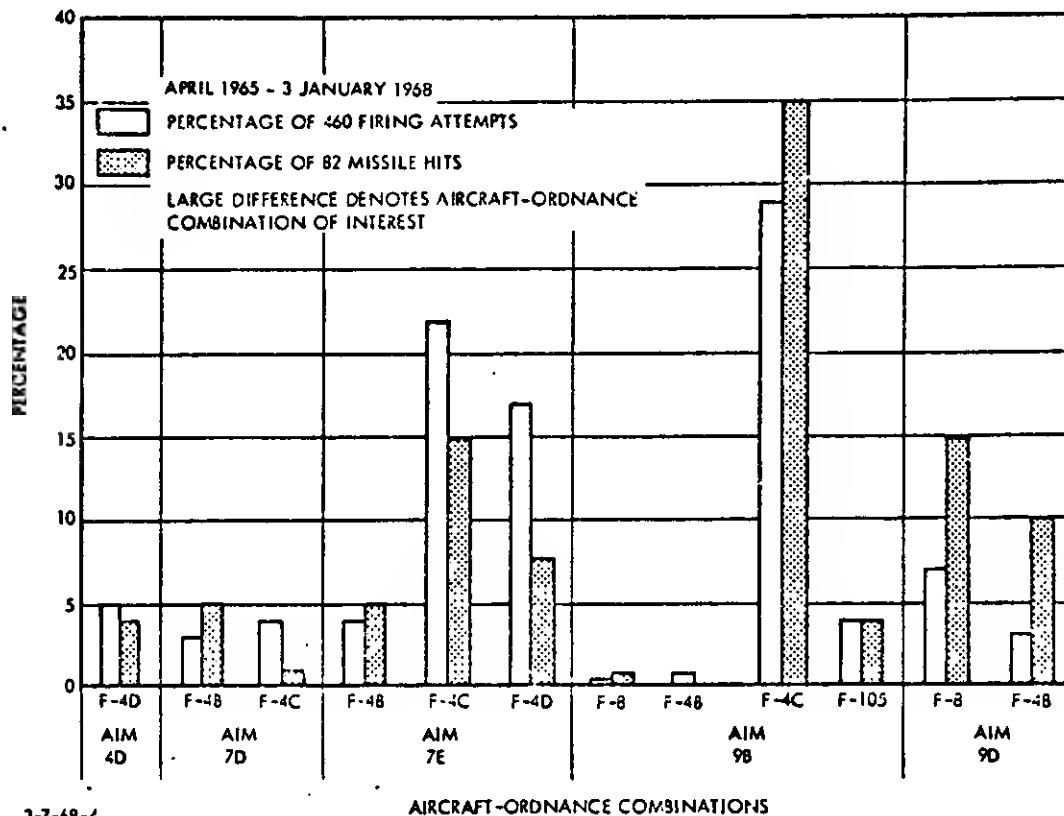
(S) The desired result of a missile firing attempt is a target hit. In this sense all results in the other categories (with the possible exception of desperation firing) must be considered a nonsuccess. Figure III-C15 shows the percentage of firing attempts together with the percentage of hits for each aircraft-ordnance combination (data through 3 January 1968). Again the combinations are heterogenous (at the 2.6-sigma level). The AIM-9D hit ratio was significantly higher than that of the other missile types. No significant difference could be detected among the remaining missile types. (Note that the zero hits of the AIM-9B/F-4B do not negate this conclusion because the sample size is small).

FIGURE III-C15 (S). Comparison of Aircraft-Ordnance Combinations for Percentage of Missile Hits (U)

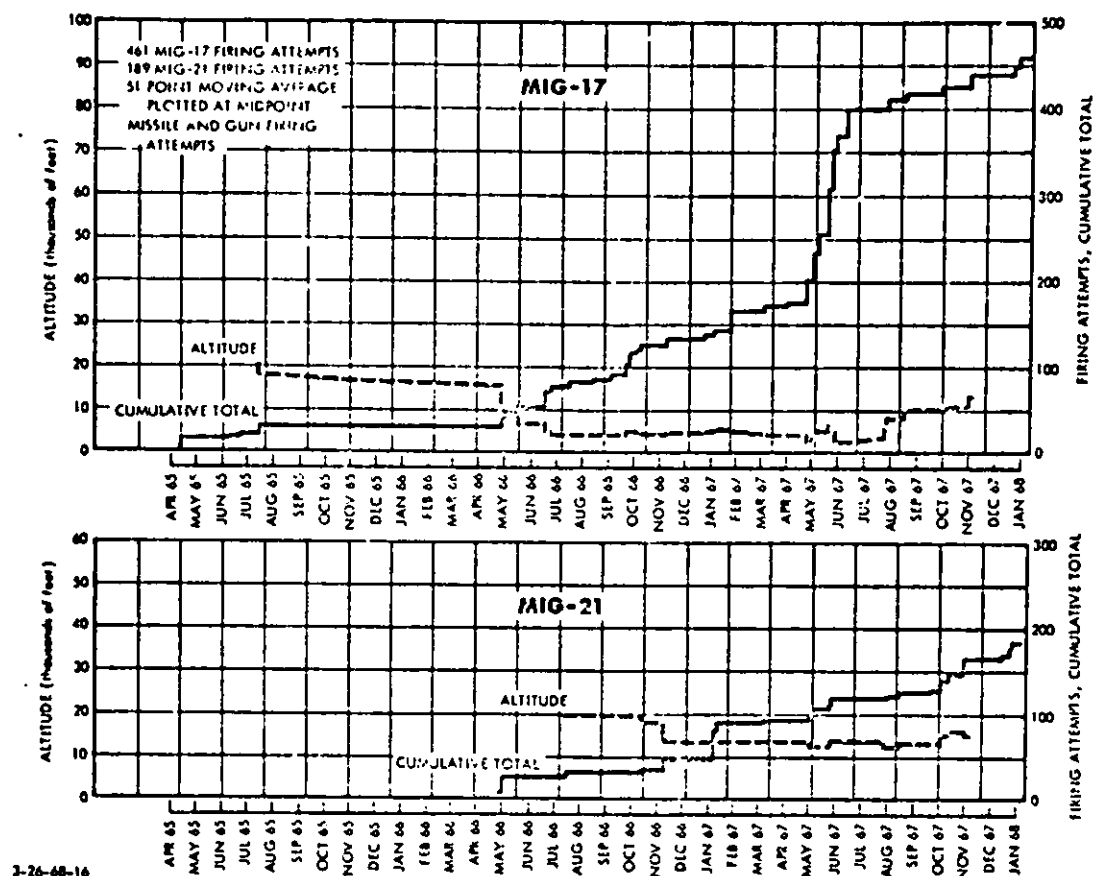
FIGURE III-C22 (S). Altitude of Firing Attempts by Target Type (U)

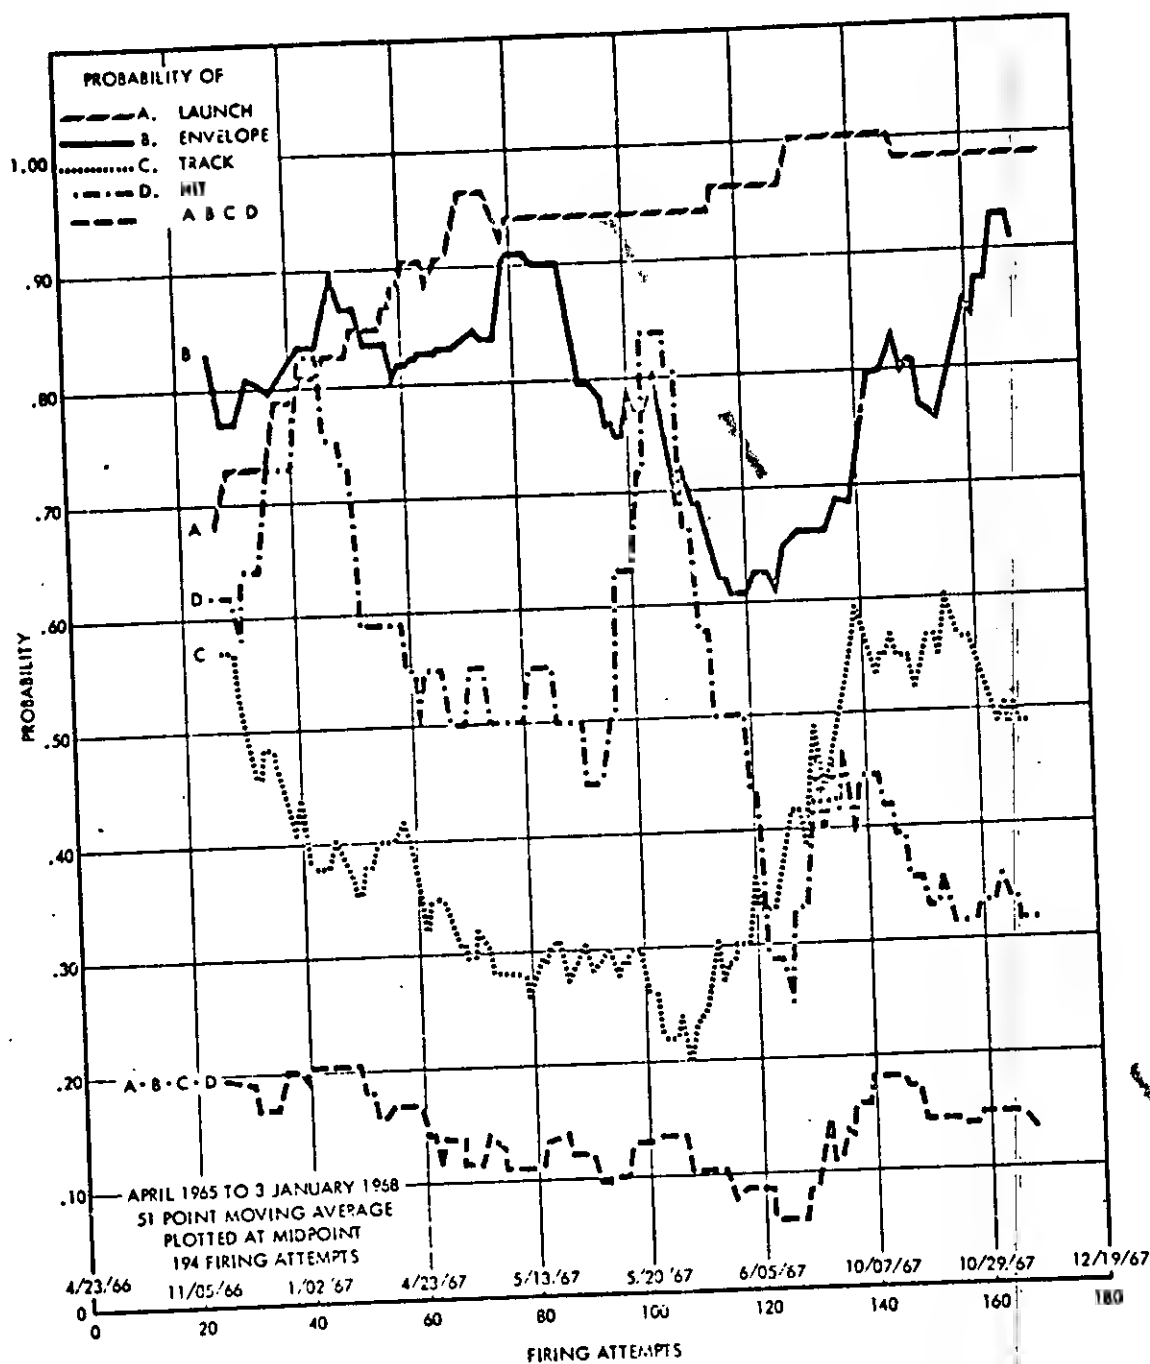
FIGURE III-C23 (S). Trends of AIM-7E Probability Factors (U)

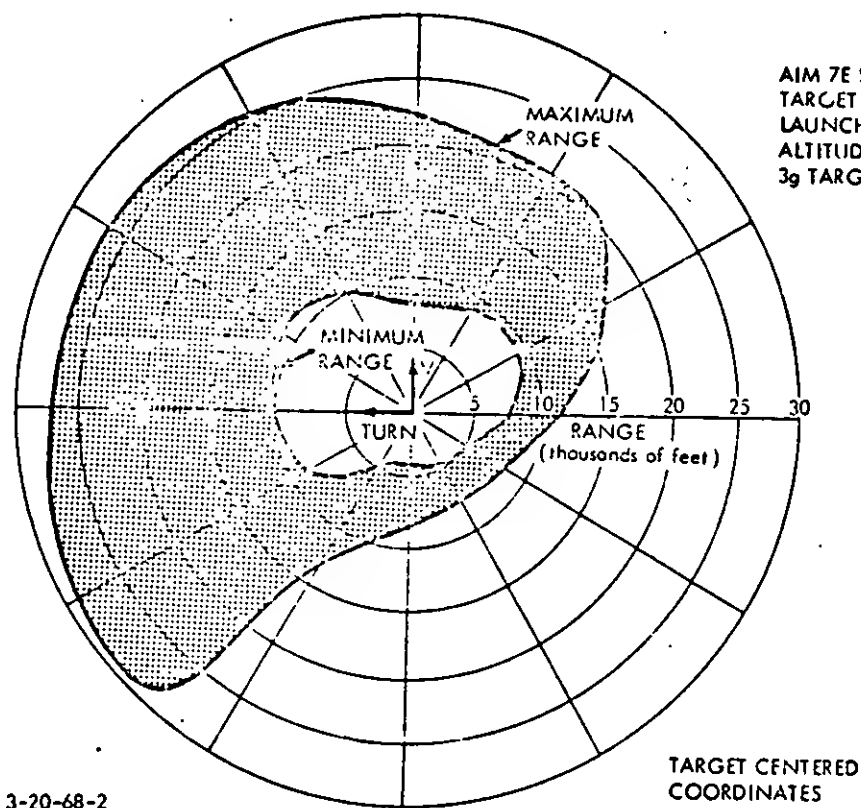
FIGURE B1 (S). AIM 7E Missile Launch Envelope (U)

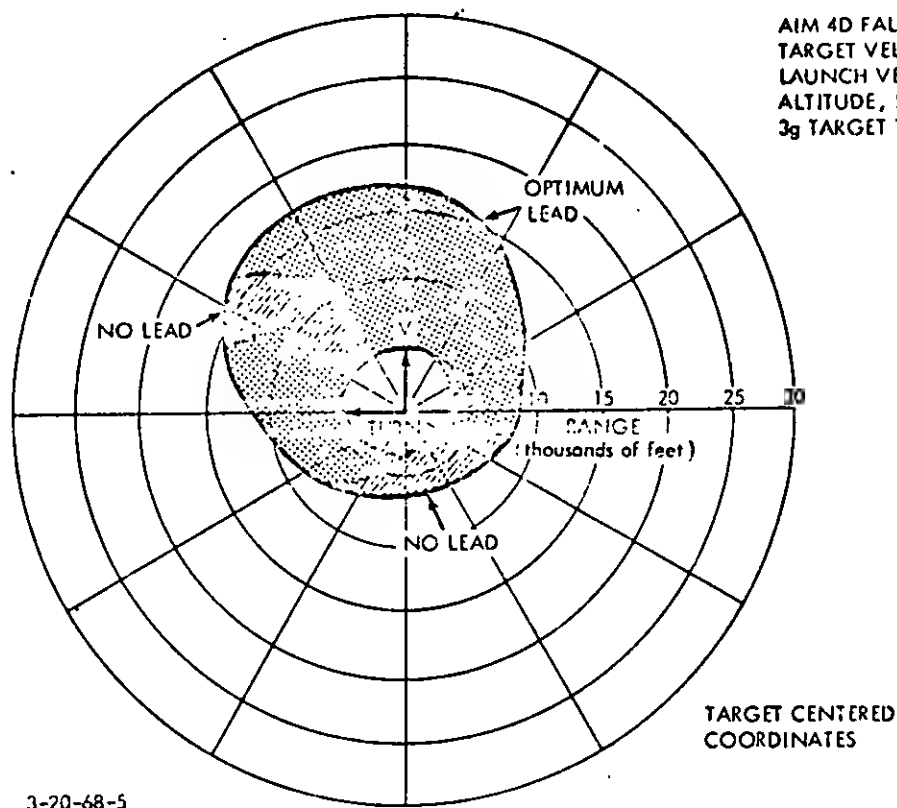
FIGURE B4 (S). AIM 4D Missile Launch Envelope (U)
